Facts on FURNACE FLUE LINER

In Masonry Chimneys

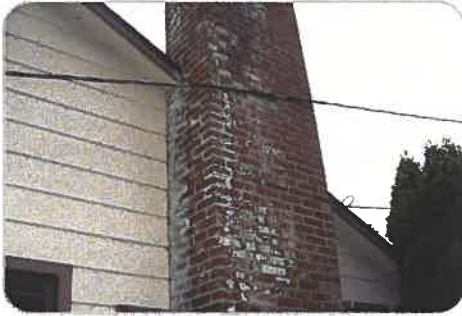
EFFLORESCENCE ON BRICK
Efflorescence is a common symptom of condensation in the chimney, leaving behind white salt deposits.

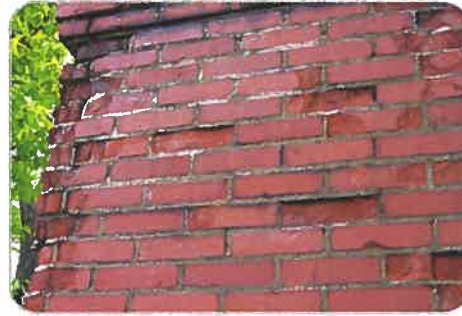
DAMAGED BRICKWORK ABOVE THE ROOFLINE
This is a result of years of condensation on a masonry chimney. Masonry chimneys either need rebuilding or tuckpointing to repair this issue, after a furnace liner is installed.

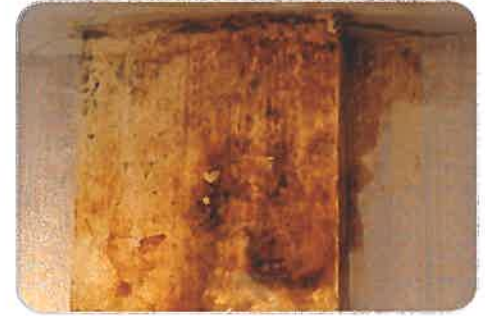
STAINING ON WALLS INSIDE THE HOME NEAR THE CHIMNEY.
If problems with a leaky chimney go unaddressed, it could lead to thousands of dollars of damage to your home.

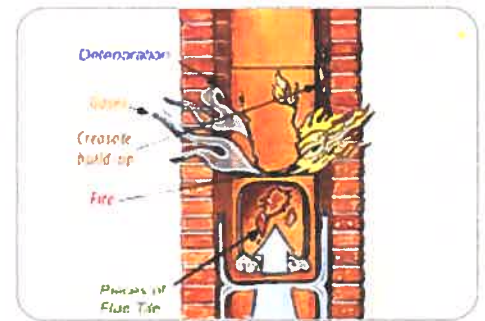
CARBON MONOXIDE GETTING INTO HOME

Carbon monoxide is often referred to as the silent killer. This poisonous gas is both colorless, odorless and tasteless. Mild exposure to the gas can lead to flu-like symptoms.

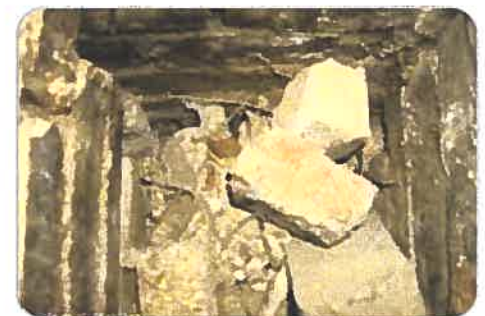
BLOCKAGES IN FLUE

Flue tiles can become damaged due to condensation and block the chimney, causing a carbon monoxide problem in the home.
